**USAF  
INVESTIGATION  
OF  
MAJOR AIRCRAFT  
ACCIDENT**

**A-12 S/N 125**

**5 JANUARY 1967**

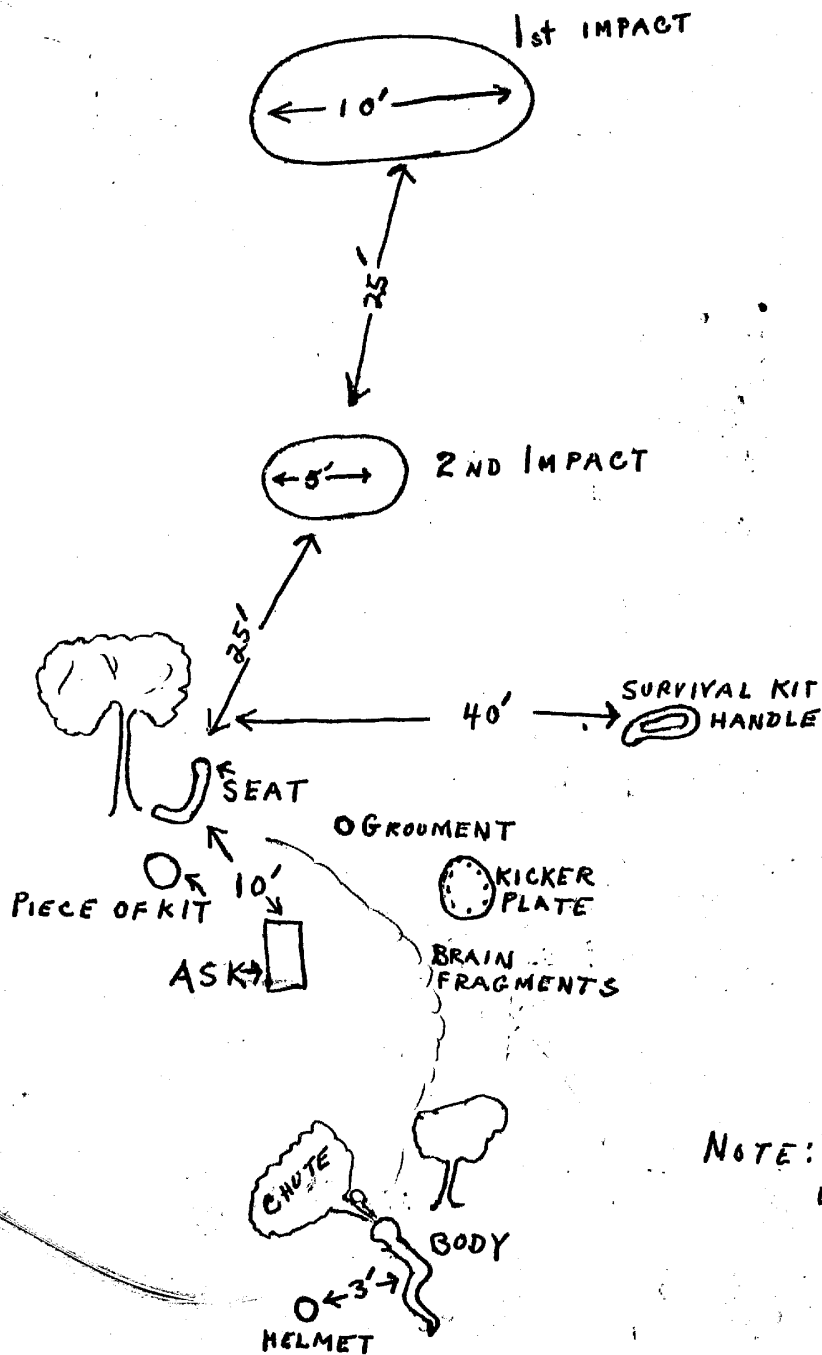
NOTE: FROM SEAT TO BODY WAS APPROX 50'

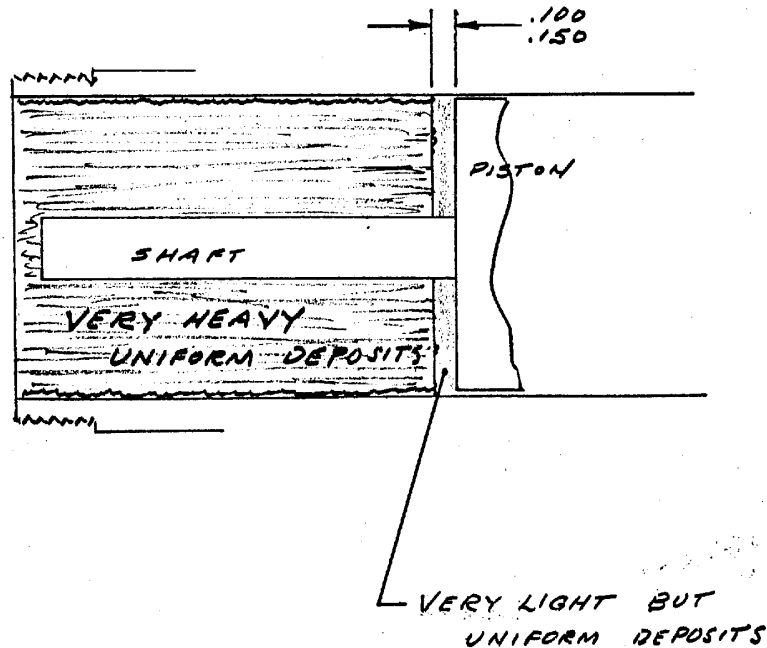
This final light deposit may have been caused at impact when the strap was allowed to take up another 3/4 inch due to seat distortion; or may have been the result of the piston being moved to the left due to accelerations on impact and then repositioning to the right. All indications are the unit performed normal and definitely stroked all the way upon actuation. The deposits could not be as they are if the unit stroked only partially during cartridge burning and then stroked the remaining distance later.
